Side Emergency Exit Windows Latch Shim

Bus, Passenger Window Plastic Guide

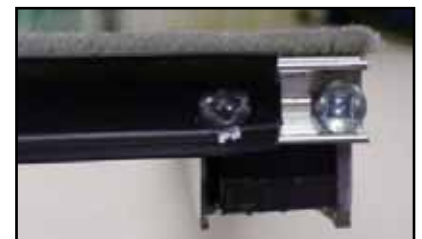
Drill a 3/16" hole in the plastic guide.

Reinstall the guide and assembly screw. Reassemble window and reinstall.
