Bus Entrance Door Locks / Vandal Lock Pin

Source: iKNOW article IK1600229

Applies To: Bus CE and RE 2017 and newer RE and CE bus with optional vandal lock feature 047DEH. This document will guide the user through repair installations to correct the vandal lock engaging when not intended.

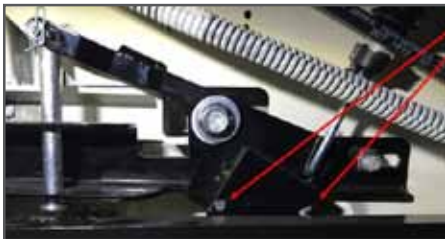
Figure 1

Root Cause: Counterweight balance rubs linkage arm, causing vandal lock to engage while unit is in operation.

1. Park vehicle on a flat surface.
2. Shift transmission to Park or Neutral, and set the parking brake.
3. Turn vehicle ignition to key OFF position.
4. Install wheel chocks.
5. Check for paint damage on counter balance per Figure 1. If there are signs of rubbing or scraping on the paint of the counter balance, adjust the FRONT door leaf tie rod to achieve a MINIMUM 1/16" gap when the door is open. Note: Front leaf may be 90 degrees or less while full open.
6. Check for loose linkage and excessive play, see Figure 2. If the pivot arm bolt is loose, remove the bolt. Apply Loctite 242 to the threads, reinstall and tighten pivot arm bolt to 24 ft-lbs (+/- 3 ft-lbs).
7. Check the pin hold down force using a force gauge. If force is not between 5-7 lbs, adjust the center pivot. See Figure 3. Holding the nut behind the bracket, loosen or tighten the front bolt until 5-7 lbs force is achieved.
