## Side Emergency Exit Windows Latch Shim

## Bus, Passenger Window Plastic Guide

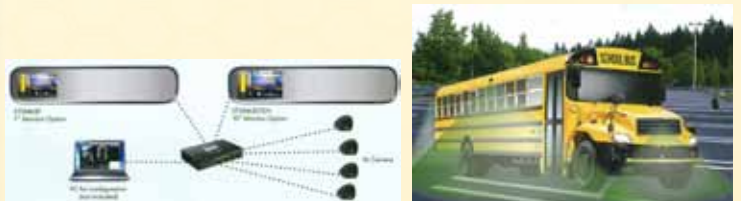
## Rosco Vision Systems SAFE-T-SCOPE 360

- 4 cameras each with 185° field of vision allows the driver to see everything around the vehicle
- Increase driver awareness
- Provide visual coverage of blind zones that are pertinent to large vehicles
- Reduce risk of collisions with vulnerable road users
- Provides clear vision on sides of vehicles for narrow roadways
- Expanded side vision when reversing into a blind zone.

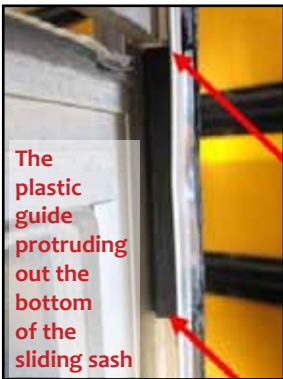
**Troubleshooting** In some cases, visual inspection of the split sash track will allow you to see the plastic guide protruding out past the bottom of the split sash.

The plastic guide protruding out the bottom of the sliding sash

To repair windows with the plastic guide visible as shown to the left, remove the window assembly and disassemble window frame to remove the sliding sash.

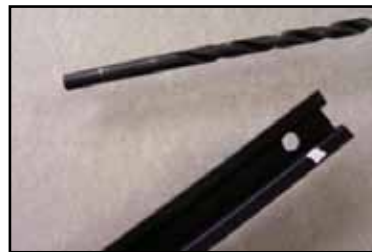
The plastic guide will be repositioned allowing the assembly screw to retain the guide. Position the plastic guide end approximately centered between the removed screw and the remaining screw. Mark the plastic guide in preparation of drilling.

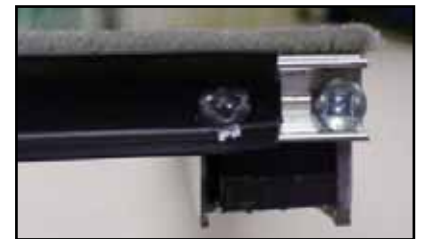
Drill a 3/16" hole in the plastic guide.

Reinstall the guide and assembly screw. Reassemble window and reinstall.
