Side Emergency Exit Windows Latch Shim

Bus, Passenger Window Plastic Guide

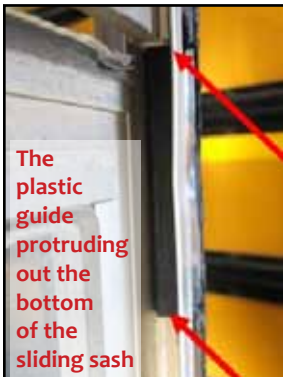
Troubleshooting In some cases, visual inspection of the split sash track will allow you to see the plastic guide protruding out past the bottom of the split sash.

The plastic guide protruding out the bottom of the sliding sash

To repair windows with the plastic guide visible as shown to the left, remove the window assembly and disassemble window frame to remove the sliding sash.

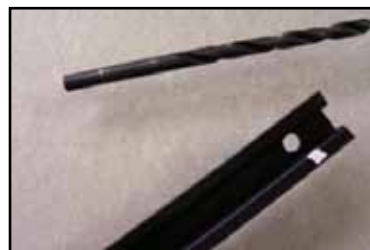
The plastic guide will be repositioned allowing the assembly screw to retain the guide. Position the plastic guide end approximately centered between the removed screw and the remaining screw. Mark the plastic guide in preparation of drilling.

Drill a 3/16" hole in the plastic guide.
