FEBRUARY 2017

— **School Bus Flyer** —

Allison 1000 and 2000 Transmission Fluid Loss from Main Housing Breather During Cold Weather Operation

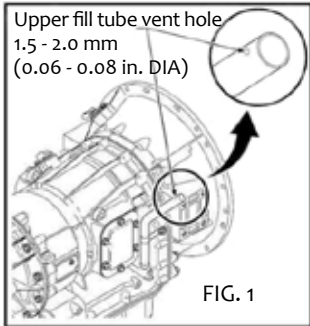
Resolution: When diagnosing transmission fluid leaking out of the breather on 1000 and 2000 transmission, first determine if the fluid level is proper and dipstick markings are accurate. If the condition persists, remove the fill tube and dipstick. Create a 1.5 - 2.0mm (0.06-0.08 inch) vent hole through the fill tube sidewall as close to the top of the tube as possible without being obstructed by the dipstick (Figure 1).

Caution: If the transmission fluid level is too high due to overfill, aerated fluid may be forced out through the fill tube or cap vent. Do not locate the fill tube opening near hot objects such as the exhaust system where exiting fluid could create a hazard. Fill tubes should also be vented below the fill tube seal and main case (Figure 2). Determine if lower vent is present, and if not, create a 1.5-2.0mm (0.06-0.08 inch) vent hole through the fill tube sidewall 31.75mm (1.25 inch) below the fill tube seal flange. Remove burrs that may damage the fill tube seal.

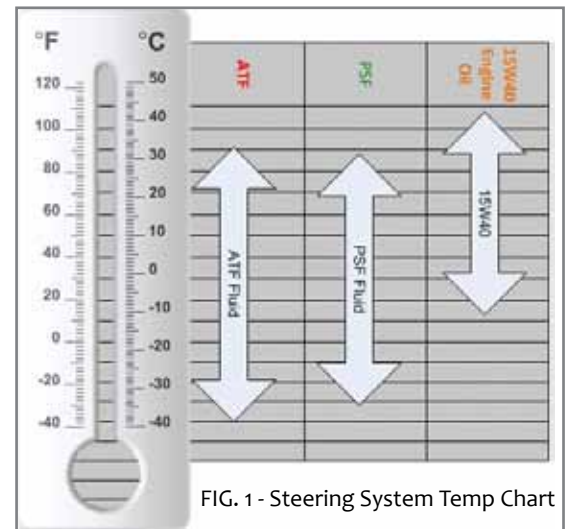
FIG. 1 - Steering System Temp Chart

All vehicles manufactured in 2017 will be factory filled with ATF fluid. This will be easily identified by red colored fluid in the steering reservoir. The new ATF fluid is backwards compatible with earlier built vehicles. Please note that every time steering fluid will be swapped a complete steering system flush is required. For ease of service there are two other applicable fluids that can be used referenced in the parts section of this iKnow. It is recommended to use the chart below to determine what fluid best fits the application of the users fleet or vehicle.
