MAY 2017

School Bus Flyer

LED Replacement Bulbs for Turn Signal Indicators on Instrument Cluster Printed Circuit Boards *Navistar SFN Number: 07-78*

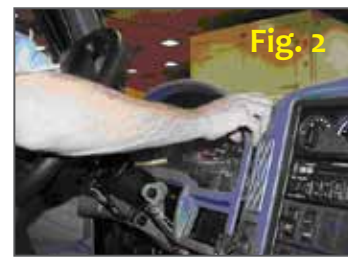
Fig. 1

1. Disconnect the negative cable and ECM ground from the battery.
2. Remove fasteners and the steering wheel lower column (**Figure 1**)
3. Remove fasteners and the instrument cluster dash trim panel (**Figure 2**)
4. Remove fasteners from the instrument cluster (**Figure 3**) and move the instrument cluster away from the dash to gain access to the harness connector (**Figure 4**). Disconnect connector and remove the instrument cluster.

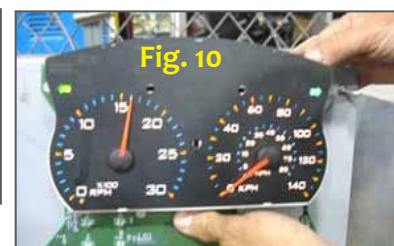
Fig. 9

9. **Figure 9** shows a replacement LED with a twist lock base. **Note** that the twist lock tab on the right side is wider (extends farther out from the base) than the tab on the left side of the base.

Narrow Tab

Wide Tab

10. Insert the replacement LED into the mounting hole. Place the wider tab as shown in Figure 9 toward the right side of the mounting hole as viewed from rear of the printed circuit board. Insert a small flat bladed screw driver into the LED base and rotate it clockwise until the stop is felt (approx. 30°). See **Figure 11**. If the replacement LED is placed into the hole with the larger lug on the left side, it will not illuminate. LED's must have the proper polarity to function properly.
