**MAY 2017**

**School Bus Flyer**

## LED Replacement Bulbs for Turn Signal Indicators on Instrument Cluster Printed Circuit Boards *Navistar SFN Number: 07-78*

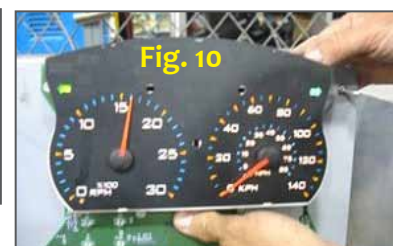
Fig. 10

**NOTE:** The color of the replacement LED will be a yellowish green as apposed to the dark green of the original turn indicator-see **Figure 10**. For uniform appearance at minimal cost, replace both left and right turn indicators at the same time while the back of the board is accessible.

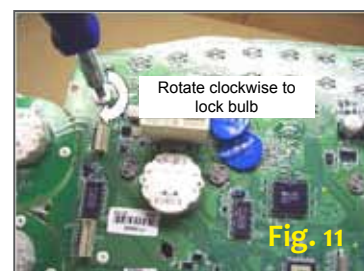
Fig. 11

10. Insert the replacement LED into the mounting hole. Place the wider tab as shown in Figure 9 toward the right side of the mounting hole as viewed from rear of the printed circuit board. Insert a small flat bladed screw driver into the LED base and rotate it clockwise until the stop is felt (approx. 30°). See **Figure 11**. If the replacement LED is placed into the hole with the larger lug on the left side, it will not illuminate. LED's must have the proper polarity to function properly.

Rotate clockwise to lock bulb
